Wessex Route CP6 Year 1 - Vegetation Management Site Specification – Wokingham to Reading

Wokingham Station to Reading Station

PRELIMINARY ECOLOGICAL APPRAISAL

RDG2 WOKINGHAM JUNCTION TO READING RAILWAY STATION VEGETATION CLEARANCE WORKS

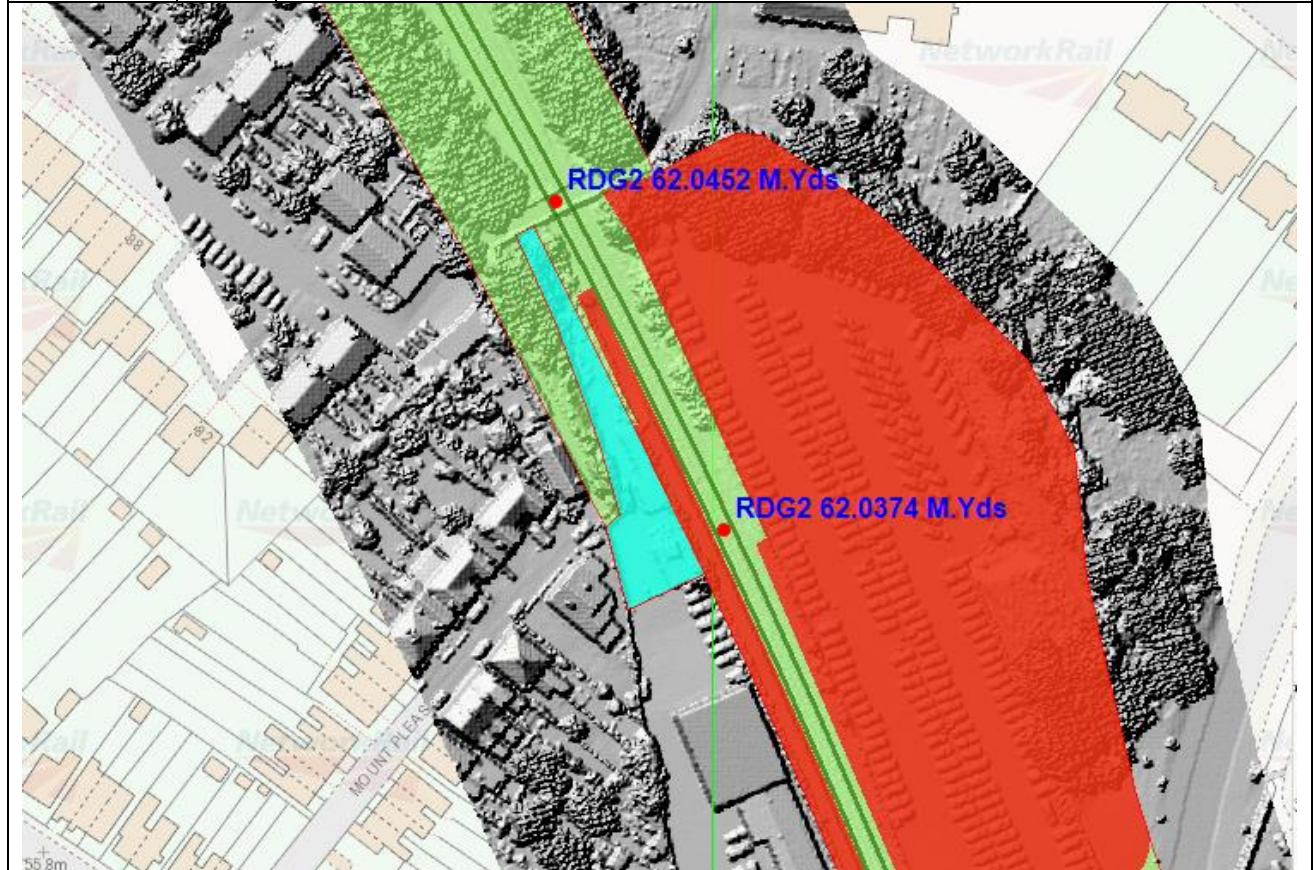
6. Work Specification		
Mileage of Work	Line	Description of Work
62.0374 – 62.0452	Up	Wokingham Station to bridge 19/1379 Church Path Footbridge. Clear all vegetation, mainly buddleia to fence.
	Down	Wokingham Station to bridge 19/1379 Church Path Footbridge, including small railway yard at the back of platform. Clear to 6 metres ignoring fence line (some clearance within the railway yard).

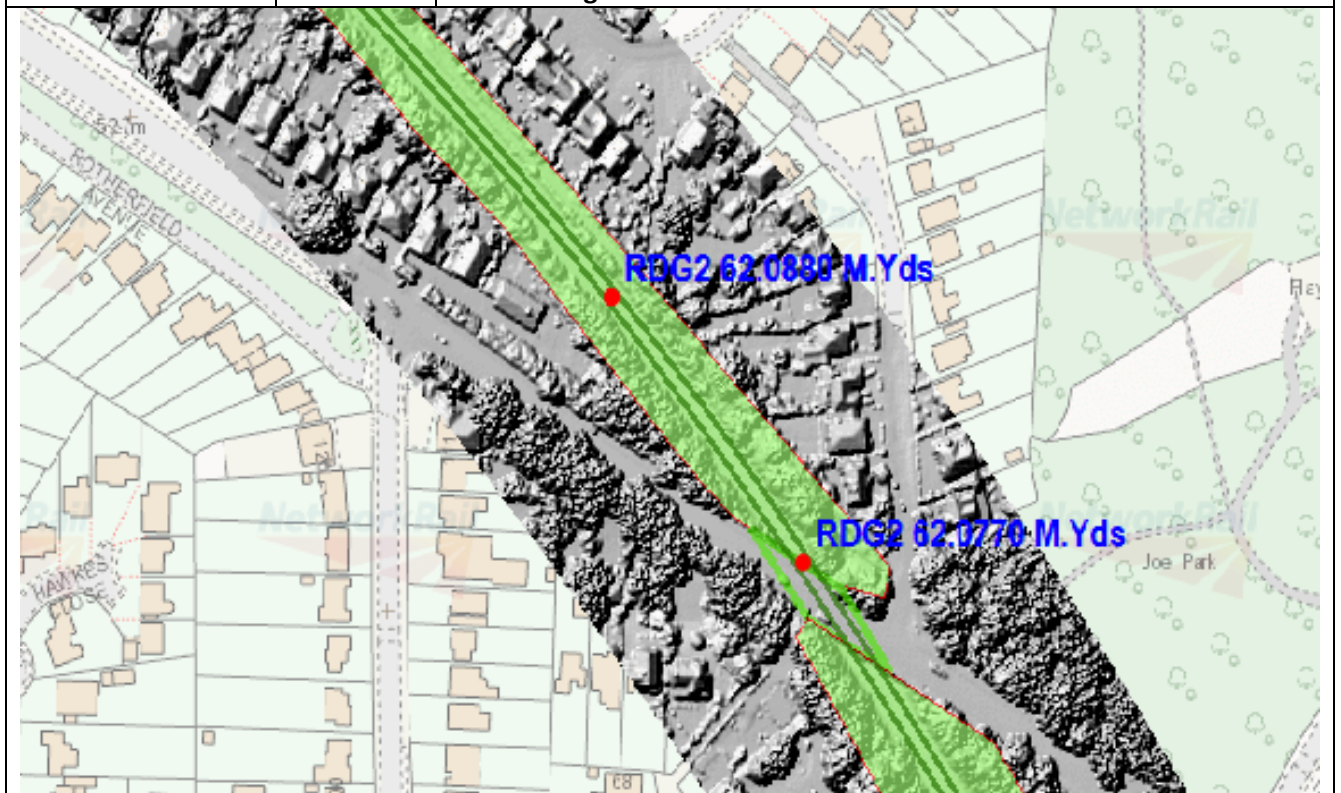
62.0770 – 62.0880	Up	<p><i>Railway through this section is on a curve which makes it more hazardous for staff walking alongside the tracks. Management of vegetation will increase sighting distances and thus safety for track staff. Leaf fall species through this section need to be addressed.</i></p> <p>Clear all vegetation to 10 metres. Clear all Sycamore to fence line.</p>
	Down	<p><i>Railway through this section is on a curve which makes it more hazardous for staff walking alongside the tracks. Management of vegetation will increase sighting distances and thus safety for track staff. Clearance of vegetation to fence line mitigated by dense vegetation on neighbouring land.</i></p> <p>Clear all vegetation to fence line.</p>

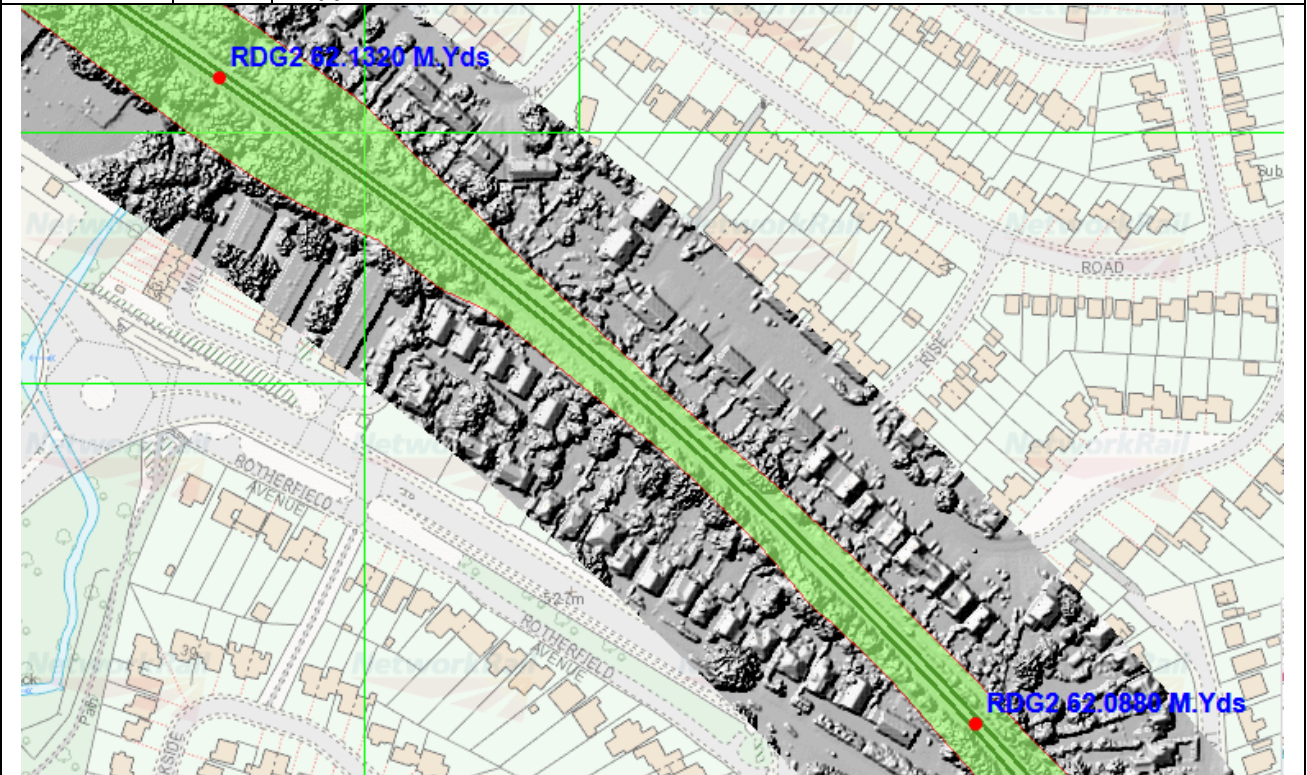
62.0880 – 62.1320	Up	<p><i>Railway through this section is on a curve which makes it more hazardous for staff walking alongside the tracks. Management of vegetation will increase sighting distances and thus safety for track staff.</i></p> <p>Clear all vegetation to 7 metres.</p>
	Down	<p><i>Railway through this section is on a curve which makes it more hazardous for staff walking alongside the tracks. Management of vegetation will increase sighting distances and thus safety for track staff. Leaf fall species through this section need to be addressed.</i></p> <p>Clear all vegetation to 7 metres. Clear all Ash, Birch, and Willow to fence line. Coppice all Hazel from 7 metres to fence line.</p>

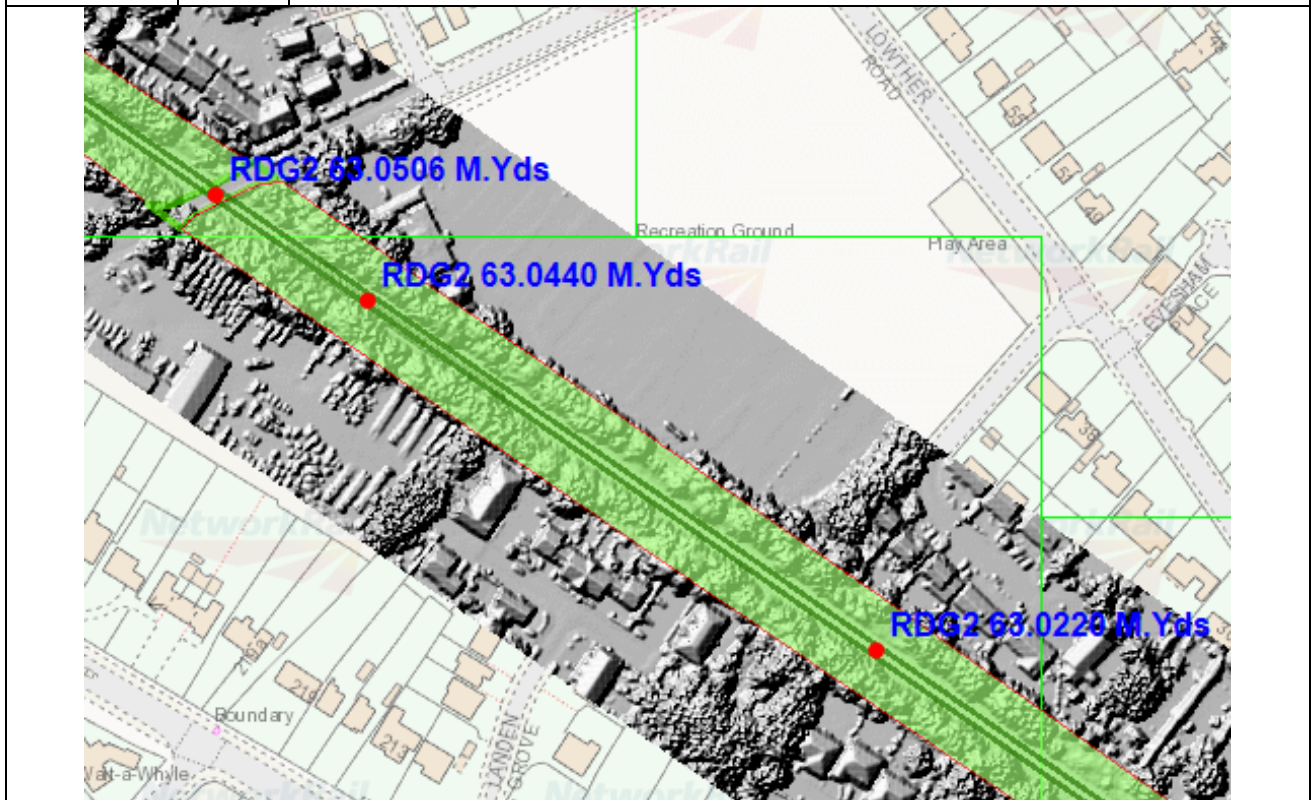
63.0220 – 63.0440	Up	<p><i>Shallow cutting slope with dense tree growth – leaf-fall species to be removed.</i></p> <p>Clear all vegetation to 8 metres. Clear all Birch, Willow and Sycamore to fence line.</p>
	Down	<p><i>Shallow cutting slope with over-mature coppice which requires management. Hedgerow species to be retained.</i></p> <p>Clear all vegetation to fence line except for: Hawthorn, Elder, Bramble. Coppice Hazel and Laurel.</p>
63.0440 – 63.0506	Up	<p><i>Shallow cutting slope with dense tree growth – leaf-fall species to be removed.</i></p> <p>Clear all vegetation to 10 metres. Clear Sycamore and birch to fence</p>
	Down	<p><i>Shallow cutting slope with over-mature coppice which requires management. Hedgerow species to be retained.</i></p> <p>Clear all vegetation to 10 metres. Clear Birch and willow to fence.</p>

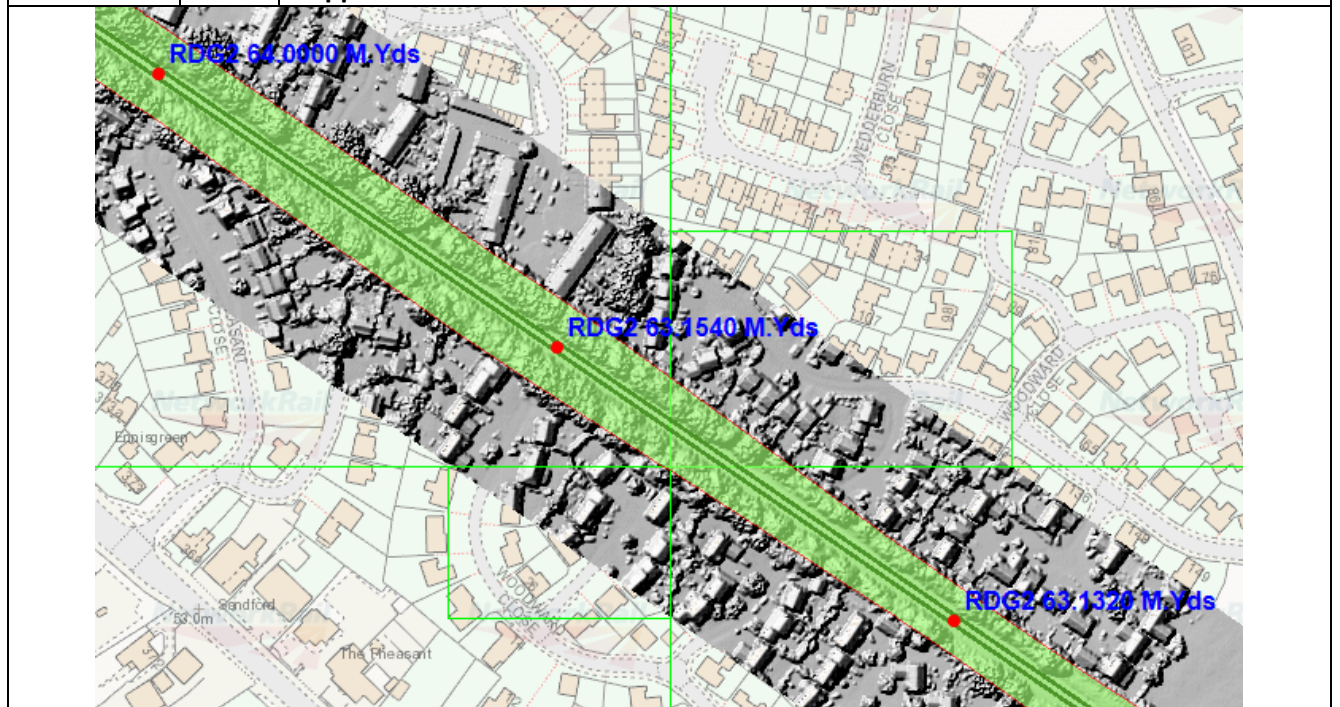
63.1540 – 64.0000	Up	<p><i>This section has many earthworks issues and is being monitored for desiccation. Specified clearance manages leaf fall species and creates a safe cess / walking route for staff.</i></p> <p>Clear all vegetation to 10 metres.</p>
	Down	<p><i>This section has many earthworks issues and is being monitored for desiccation. Specified clearance manages leaf fall species and creates a safe cess / walking route for staff.</i></p> <p>Clear all vegetation to 8 metres. Coppice Hazel between 8 metres to 12 metres.</p>

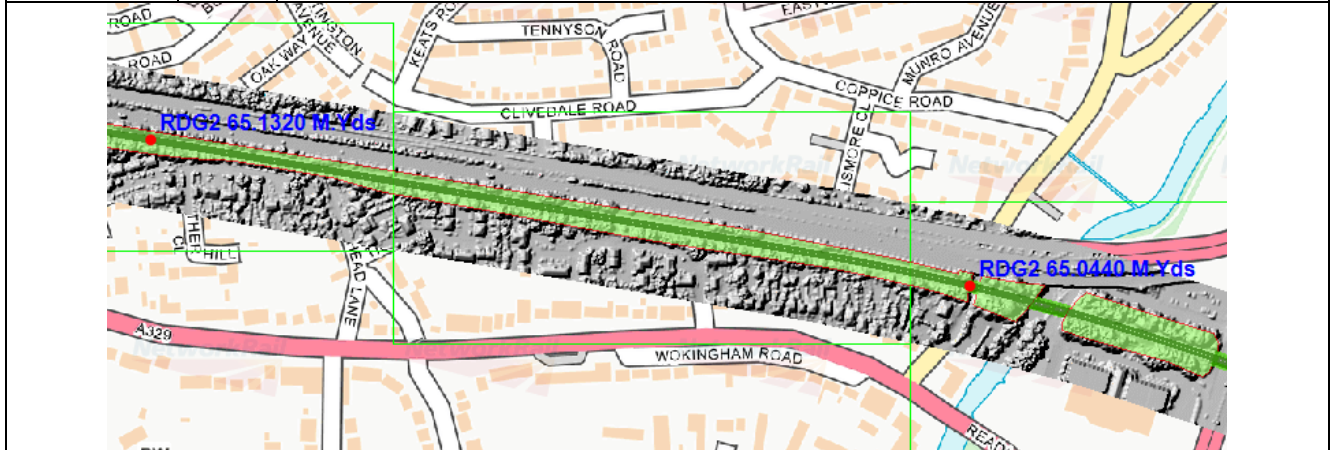
65.0440 – 65.1320	Up	<p><i>Specified clearance manages leaf fall species and creates a safe cess / walking route for staff.</i></p> <p>Clear all vegetation to 7 metres.</p> <p>Clear all Sycamore and Willow to fence line.</p> <p>Fell 3rd party Goat Willow at 65m 41ch.</p>
	Down	<p><i>Specified clearance manages leaf fall species and creates a safe cess / walking route for staff.</i></p> <p>Clear all vegetation to 8 metres.</p> <p>Clear all Birch, Ash and Willow to fence line.</p>

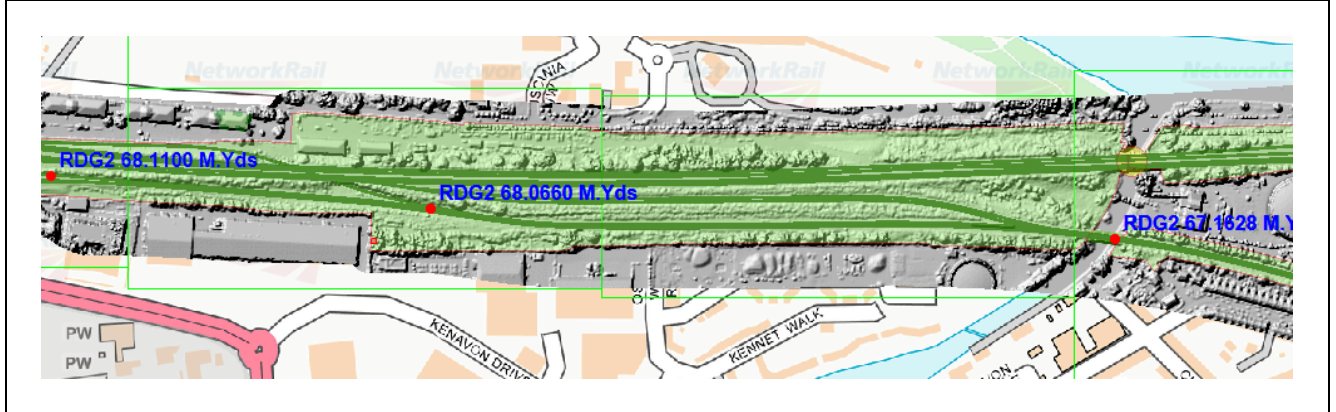
67.1628 68.1100	Up	<p>Vegetation through this section is mainly Buddleia. This section approaches Reading station and runs alongside the Great Western mainline (MLN1) which is electrified with overhead lines.</p> <p>Clear all vegetation to 10m between 67.1628 and 68.0660. Clear to base of retaining wall between 68.0660 and 68.1100.</p>
	Down	<p>Clear all vegetation to 10m.</p>

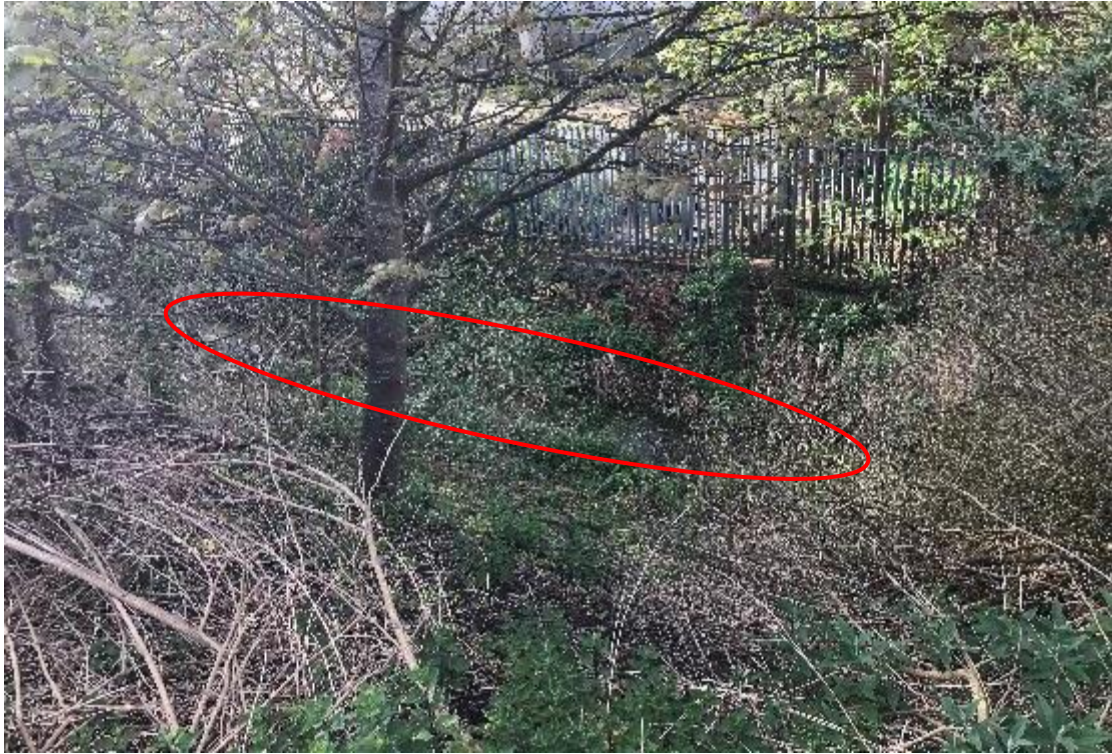
Image 13. Ditch at bottom of embankment near River Kennet.

Great Crested Newts: One waterbody was identified within the clearance area and comprised of a small ditch located at the bottom of the embankment east of Reading Station (Grid Reference SU 7287 7327, Image 13 in section 6). However, the ditch was found to be of very low value for GCNs, with low water levels, poor water quality and a lack of suitable vegetation for egg-laying. In addition, there were a general lack of ponds within the surrounding area. Of those that were present, major roads or built-up urbanised

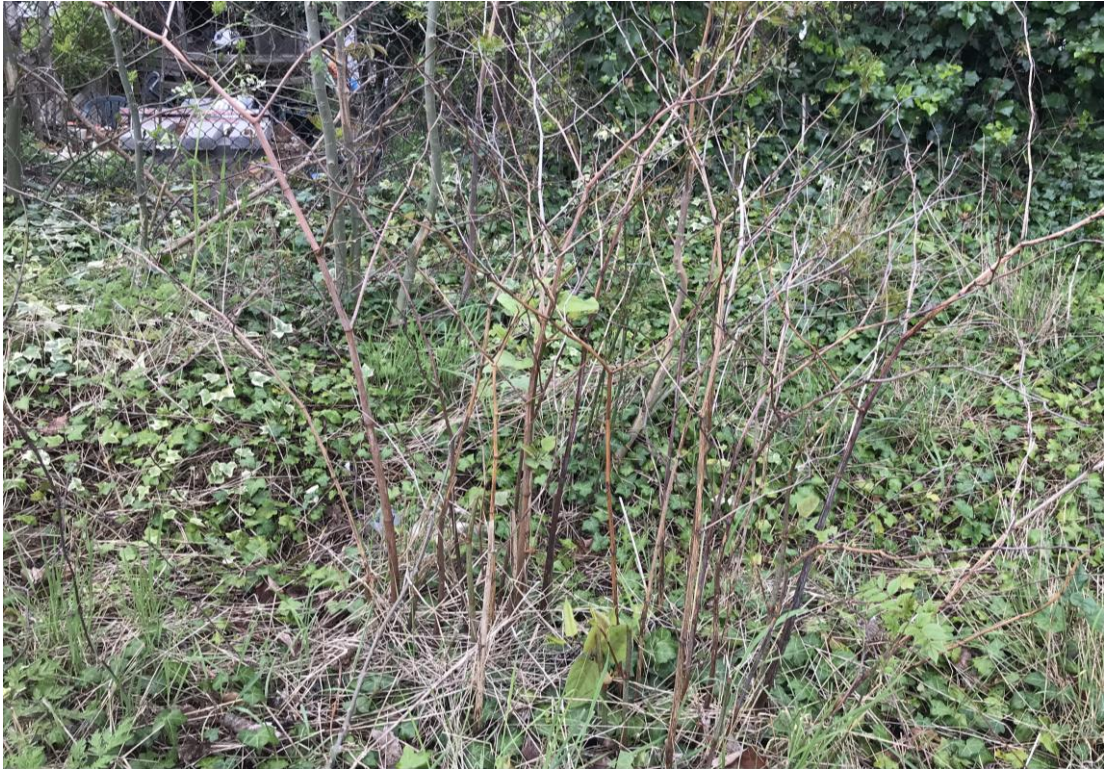
Image 17. Knotweed stems noted at 67M 62.7CH.

- In addition, due to its potential to have a significant negative impact both ecologically and structurally, it is recommended that a full treatment programme is carried out to eradicate the Japanese knotweed from the areas where it is present.

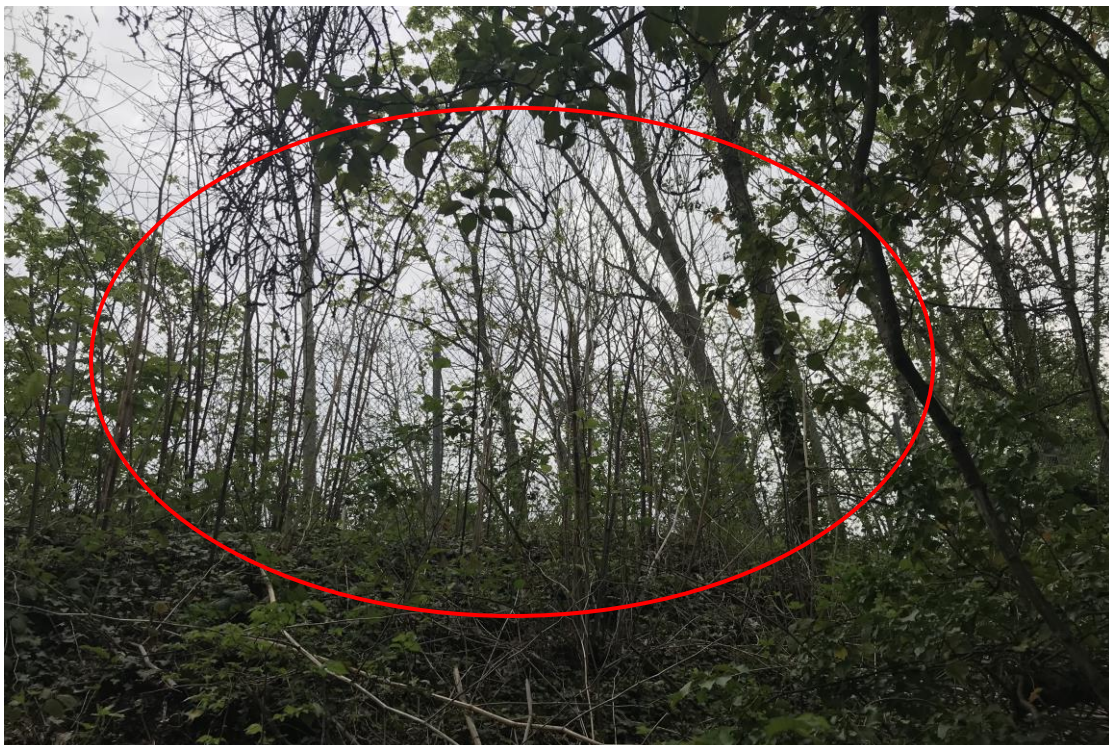
Image 18. Knotweed stems noted at 66M 49.5CH.
